# A Case Study on Rehabilitation of RCC Machine Foundation of a Cement Mill Structure

**Abstract**—The present cement mill is supported over two RC foundations. Foundation at outlet portion is also supporting mill driving motor and gear box and it is higher in size. Foundation at inlet portion is smaller in size and supporting only mill drum slide shoe bearing. Distresses are noticed only in foundation below outlet portion, which is supporting motor and gear box also. This foundation is rectangular in plan and it is a solid RCC foundation. It is supported on hard rock stratum.

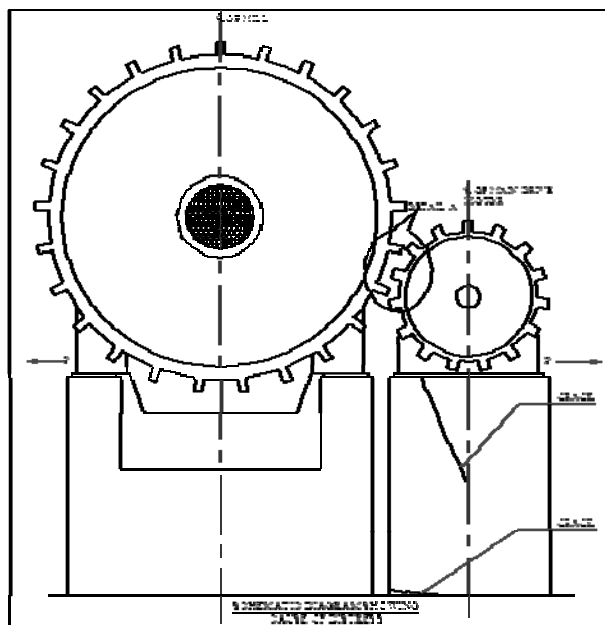
Fig.2 : Sectional elevation showing gear arrangement

Driving mill motor rotates in anticlockwise direction and mill drum rotates in opposite clockwise direction. During running condition one tooth of gear shaft attached to driving motor was broken. As it was rotating in anti clockwise direction, due to gravitational force broken part of gear tooth fell into the space between next two gear teeth. Free space between two gear teeth is less than volume of broken gear tooth; as a consequence, a huge horizontal force is created between mill drum and driving motors. This created /induced horizontal force at gear teeth level is transferred to the foundation through anchor bolt and thus generated a huge moment at ground level of mill foundation. Generation of this additional moment resulted cracks on the mill foundation. Causes of distress are schematically shown in Figs.2, 3 & 4.

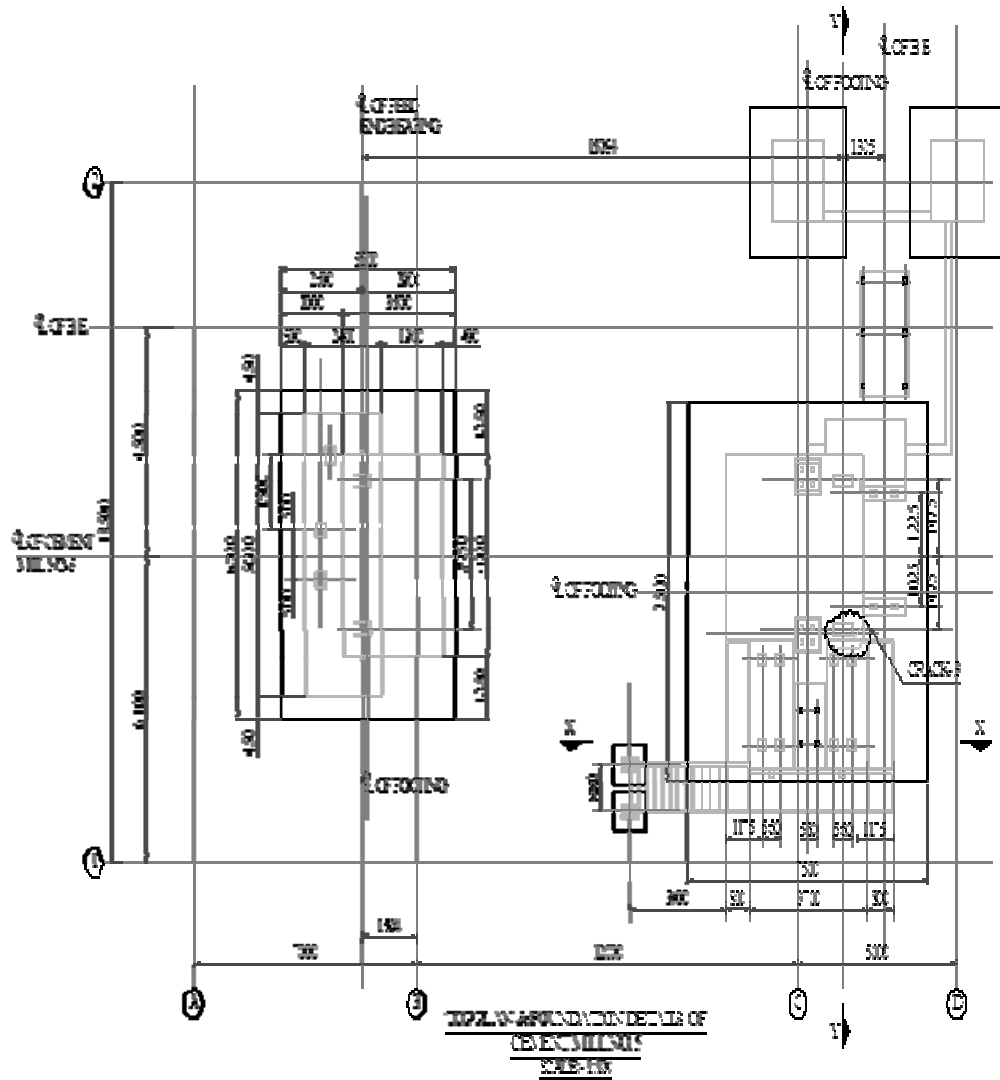
Fig.4: Plan showing different parts of cement mill foundation

Thorough visual inspection and Non-destructive tests were carried out to ascertain the existing condition and extent of damage of the foundation. Major damages noticed on the foundation of Cement Mill No.-5 are in the form of cracks. All major cracks are described below with sketch (Fig.5 & 6).

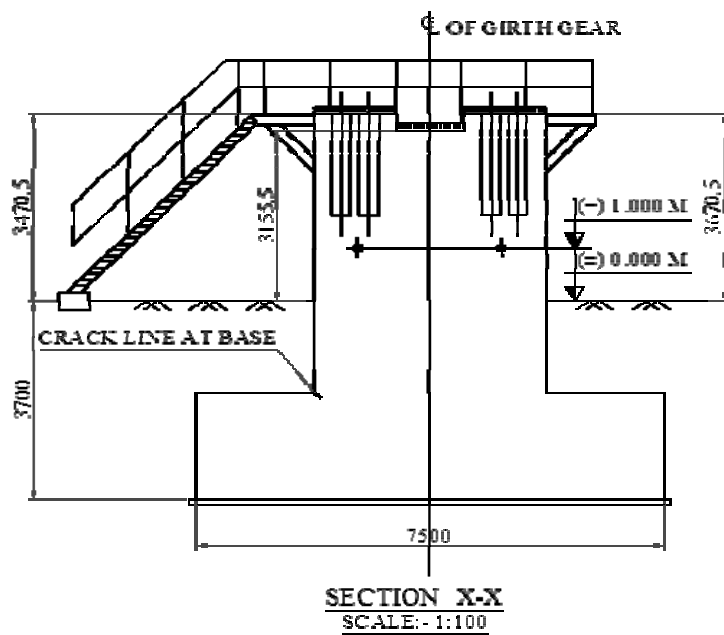
Fig.5: Section showing cement mill foundation

Crack No -1 which is generated at the ground level. Width of the crack being more at cement mill drum side and narrowing down towards the driving mill motor side.

From close observation, it was noticed that Crack No-1 was generated along the construction joint and that crack was almost through and through type in nature.

**Crack No-2** is generated at 1.2m above Crack No -1. The nature of the cracks was same as Crack No-1. This crack was generated at the level of construction joint of the RC foundation.

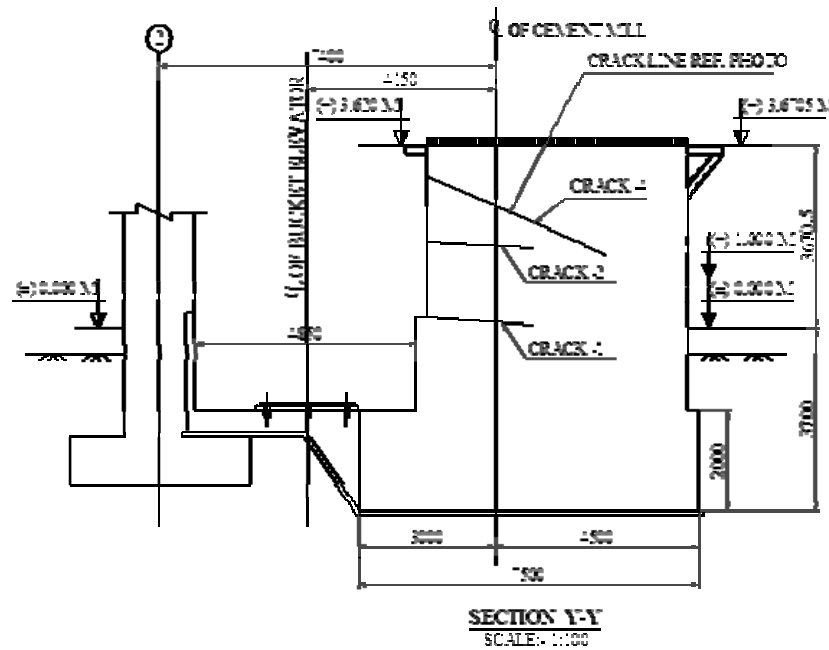
Fig.6: Section showing cement mill foundation in other direction.

**Crack No-3:** It was vertical in nature. This crack was visible from top level also. From top level this crack was noticed near the anchor bolt of driving motor foundation. The width of the crack is about 10 to 15mm at top of foundation and narrowing in nature towards downward.

**Crack No-4:** It had the narrowest width and nature of the cracks was inclined around 45° with respect of horizontal plane. Highest width of this crack was noticed on outer surface of foundation at mill drum side.

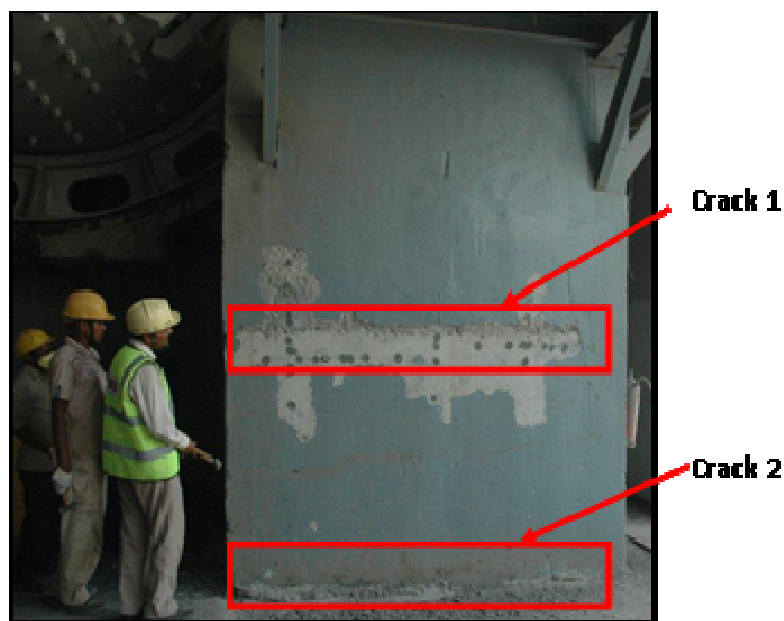
All major cracks were very prominent in nature and through and through type. UPV test was done to ascertain the condition of existing concrete condition and to ascertain any presence of any further cracks. UPV test was done extensively on the foundation structure. All the cracks had higher width at the mill drum side and width was reducing towards opposite side, which signifies that horizontal force pushed the foundation in an out ward direction. Conditions of concrete at other areas except some cracks are found to be satisfactory as per ultrasonic Pulse Velocity testing method.

Fig.7: Elevation of cement mill foundation showing major crack position

From visual inspection and NDT it is clearly understood that all cracks are generated due to sudden generation of huge horizontal force at the bearing level and these cracks are very prominent in nature. Most of the cracks are through and through. Cause of distress is due to accidental load and further chance of generation of that kind of load is very minimum. Condition of concrete at other parts of foundation is in good condition, so it may be concluded that major distress of the structure is cracks these cracks are to be repaired properly. The following points may also be noted:

- All cracks are “dead” in nature and further chance for occurrence is very less. Cracks are to be filled with material which has high compressive strength, high bond strength and very low viscous properties.
- All cracks are to be sealed with proper compatible material to re-establish the structural integrity.

- Cracks are to be sealed, so all positions of voids in crack are to be filled with epoxy – as it is a very low viscous material (CPS - 500) and material with a pressure of 3 to 4 kg/cm<sup>2</sup>, it will reach every corner of voids.

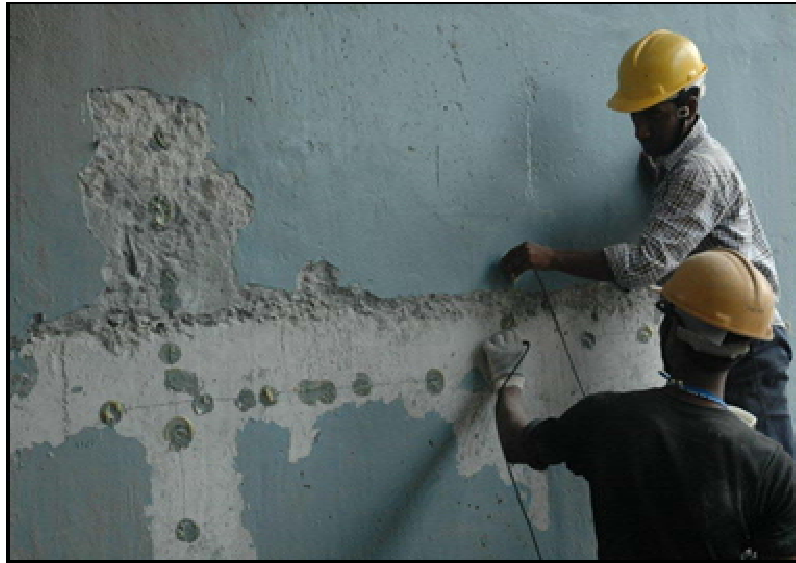
Fig.8: UPV testing is in progress.

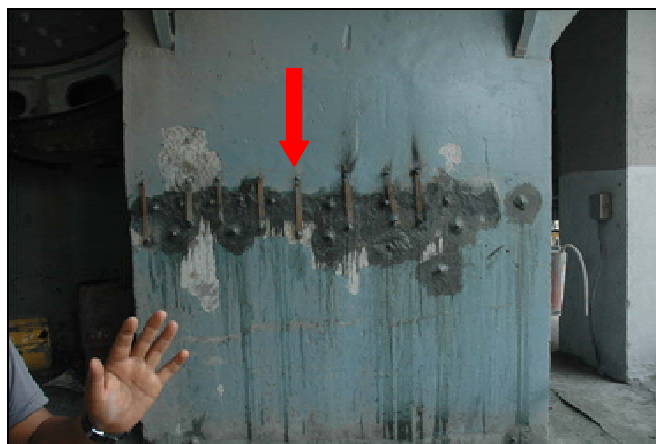
Fig.10: Photograph showing stitching with steel strip.

- Further structural movement of RC foundation is not at all acceptable. In order to ensure this, stitching with steel member was done along the crack line. Details of crack stitching is shown in Fig. No.9
