Proposition of Corrosion Expertise method for water pumping stations Application to the case of northern station of Fez city - Morocco

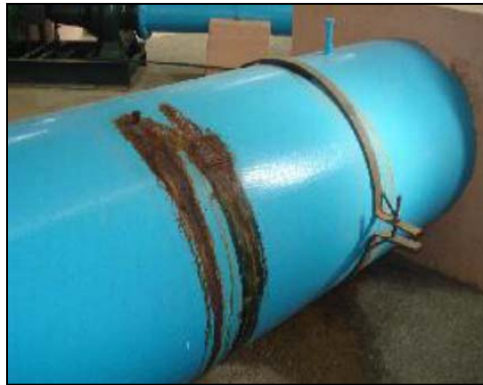
Figure 2 presents some of corrosion effects on an aspiration pipe of the northern station.

The figure shows three cracking. Internal corrosion was suspected for a first time. We can observe a rubber belt tight by a sheet metal ring working as gasket to eliminate the leakage.

By analyze more, we have observed that the fissure is starting from the weld; so it can be a bad welding method, corrosion due to the thermal and mechanical effect of welding or humidity stored in flux of the welding electrode (see figure 15 of section VI).

Fig. 2. Water leakage due to cracks; internal corrosion is suspected

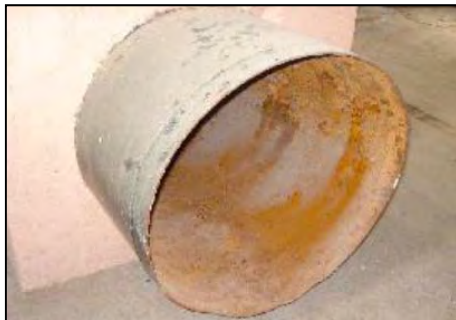
Figure 3 shows the internal surface of a forsaken pipe (January 2010 according to expertise period).

The visual diagnostic allows us to make a first affirmation that the uniform corrosion exists also into the pipe at the internal surface, and which has as effect a uniform diminution of the thickness of the pipe, accelerated also by the water erosion.

We can also see clay deposit on the internal surface of the pipe. Quality (particles in suspension: turbidity) of the water is a key point in analysis of the degradation of these equipments by differential corrosion mechanism. Therefore, we have sent the analysis of rust deposit after triacide attack to determinate its constitution. The results of the analysis are presented in section IV.B.

Fig. 3. Forsaken pipe due to a critical value of thickness

A preventive control by ultrasound permits the measurement of the thickness. When the thickness reaches a critical value, below which the pipe can't support water pressure, it is advisable to eliminate this pipe.

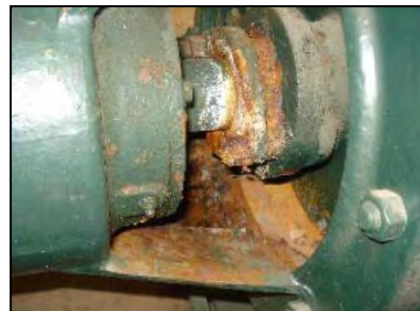
Fig. 4. – Corrosion on the drive shaft of a pump

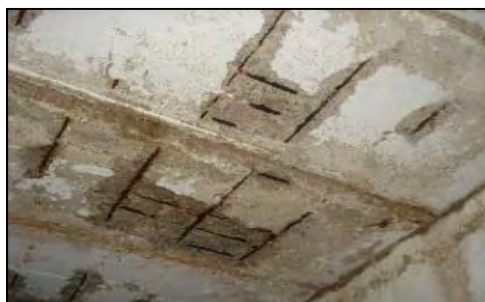
Fig. 5. State of the roof and walls affected by the humidity (Metal reinforcement is corroded)

We have also noted the existence of an important rate of humidity, especially in the vane chamber (figure 5 and 6), which causes great damages by uniform corrosion on the external surface of the pipes.

The humidity is caused here by a non effective aeration system, which is, in several cases not taken into consideration in architectural design of the stations. So the office has to make humidity measurement for all affected sites. Unfortunately, we had no time to make those tests, and we noticed that as suggestions and future perspectives.

- Measuring the humidity rate periodically to estimate its natural evolution, according to the seasons.
- Study the airing techniques of all parts of pumping stations: pumps rooms and vanes chambers.
- Making efficient gutters or other water evacuating systems to evacuate water if a leakage remains for a long time (before maintenance). Figure 5 shows the effect of water leakage in vanes chamber without any water evacuating system. So leakage water, remaining in this location, increases the humidity rate in the air. This effect is forced more and more by the absence of aeration system!
- Study the possibility of cathodic protection for the most delicate equipments even in air milieu.

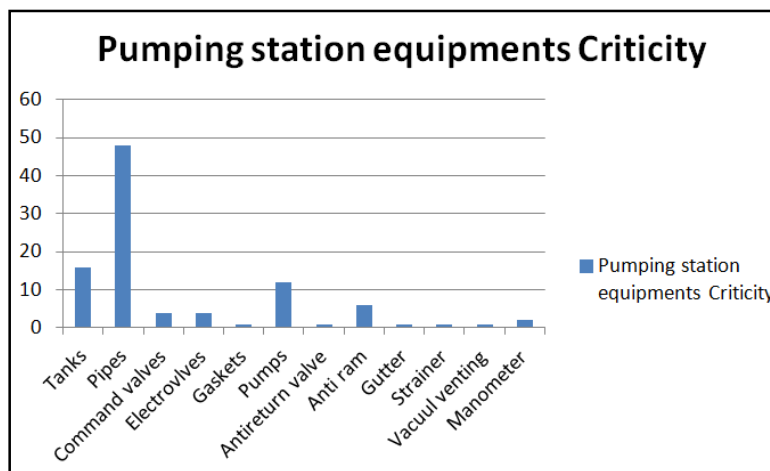
The histogram of figure 7 – (b) summarizes the results of FMEA, and shows that the pipes are the most critical equipments of all the pumping station (figure 6-(a)). Thus, they constitute the subject of the following expertise.

The other equipments (pumps, vanes, tank, seals, manometers...) have a criticality less than 16. We based the choice the critical threshold n “*CNOMO E41.50.530.N*” standard which defines 16 as critical for mechanical components) [1].

(b) Results of FMEA applied on the most critical equipments of Northern station
Fig. 7 – FMEA Analysis of Northern pumping station

So it is a must to modify some properties of the pipes (material dimensions, painting methods, isolation,...), according to the definition of our problematic (corrosion). For the other equipments, systematic or conditional verifications have to be instituted on the maintenance management system.

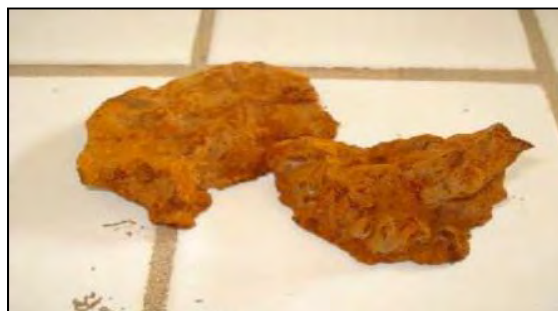
Indeed, we took a corrosion deposit from the pipe presented in figure 3, and we remark a big quantity of clay mixed with corrosion steel product (rust).

Figure 9 shows corrosion deposit from the pipe of figure 3.

The office does not use any filtration system, but only a strainer to eliminate big particles. The installing of an additional filtration system can cause a depression and will damage the normal functioning of the units.

Fig. 9 – Rust deposit from a forsaken pipe

They can install nanofilters but they have to redesign the pumps and other parts of the circuits to search the functioning points of the pumps.

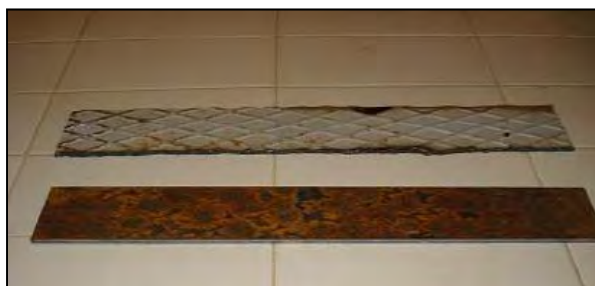
Figure 10 presents a portion of sheet metal used in the processing of water pipeline.

Fig. 10 – Sample of sheet metal used for pipes

Remark: It is necessary to use special steel, galvanized one, or efficient protection with standard steel, if not the material can be corroded easily; that is the situation in this pumping station.

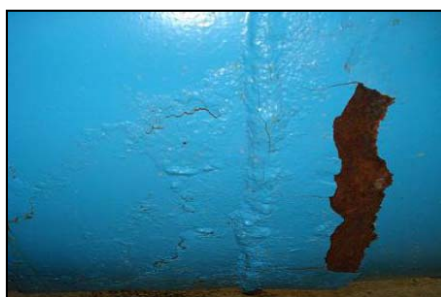
For example, figure 11 shows the result of a simple painting of pipe of northern station which can't protect the pipe from external air corrosion.

Fig. 11 – Corrosion under the paint frame

Normally, painting methods must be reviewed in the office, for home made pipe and also for the purchased ones as explained in [2].

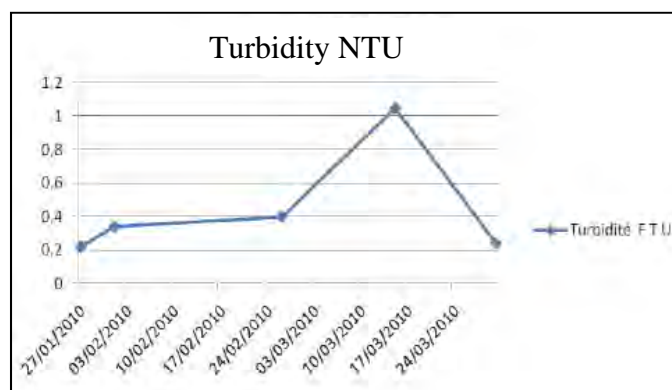
Fig. 14. Turbidity Evolution

The turbidity are around an average value of 0,3 NTU except in the week corresponding to 17/03/2010, which correspond to the highest value for the tests period (greater than 1). This big value of cloudiness of water is caused by the rain on this week.

The office has to make other turbidity analysis especially in rainy weather in winter, to have more information about the turbidity, to estimate the effect and the aggressiveness of the environment around the water (hydrology).

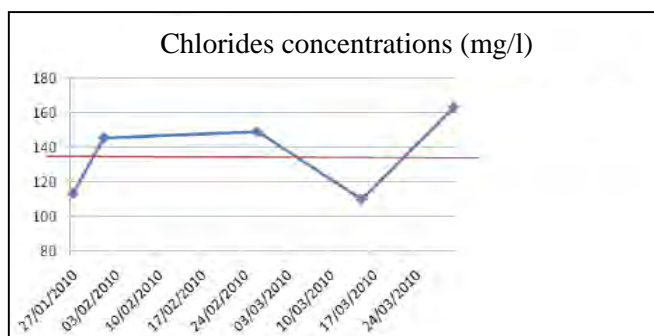
Fig. 15. Evolution of the concentration of chlorides

Figure 15 shows that the chlorides concentrations are around 135mg/l. We will see in next sections the effect of chlorides concentrations on corrosion risk.

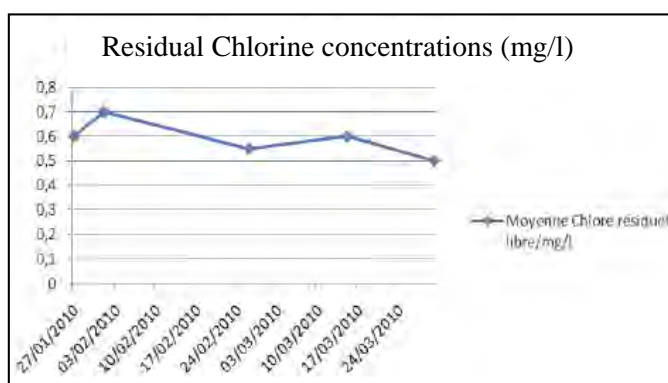
Fig. 16. Residual chlorine evolution in water

Figure 16 proves that the residual chlorides concentrations present not null values; and as we said below, a not null residual chlorine in water are correct with the prescriptions of the WHO which prescripts that it is important to have a percentage higher than 0,5 mg/l to be sure that the disinfection is done but not higher than 5 mg/l [7].

Moroccan standard NM 03.7.001 gives as prescript values between 0,1 mg/m and 1 mg/l for distribution and between 0,1 mg/l and 0,5 mg/l in the step of production [5]; but in the case of a great rate of chlorine, it can generate chemical reactions increasing the acidity of the milieu and the corrosion risk for pipe material.

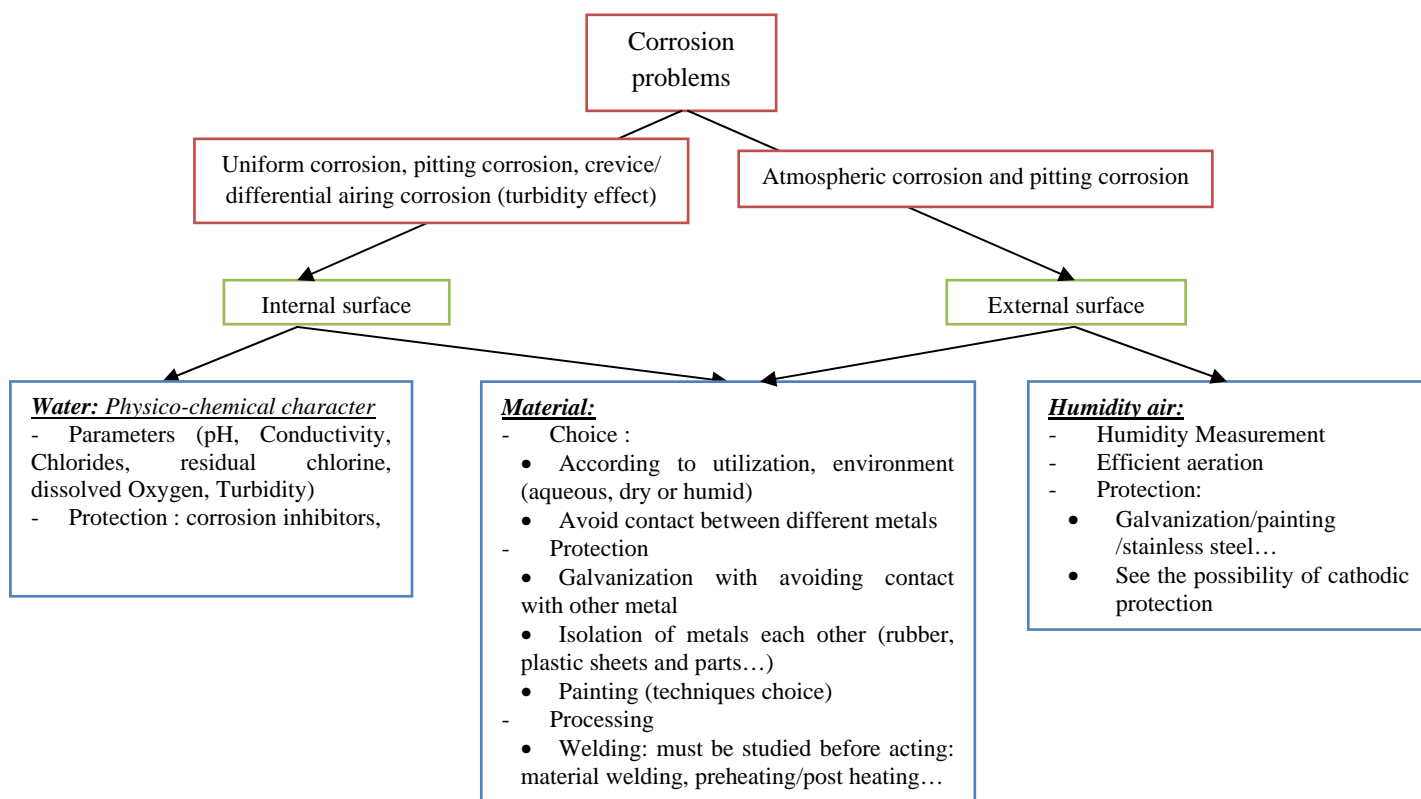
Figure 16 gives the principal forms of corrosion found on the equipments of the station and the principal corresponding causes. It constitutes a global view of the work reported in this paper.

Fig. 19. Corrosion types according to analysis variables
