Structural Behavior by Reinforcement Type in the Joint of RC Beams and Columns Mixed with Waste Tire Material

Abstract - One main purpose of this study is to measure the improvement of the ductility through structural tests of the connection between an exterior column and a beam of normal concrete in comparison with a concrete frame constructed with a mix of waste tire material. The actual section size of each column and beam is 30cm×30cm with the reinforced concrete (henceforth RC), which is based on a 1/4-scale design with exterior columns and beams. The models are termed NCJ-1, TCJ-1, NCJ-2, NCJ-3, and TCJ-3 for the six (6) types used here. It is estimated that the main rebar in the beam is not anchored over the boundary of the connection rejoin. Instead, it is anchored only to the boundary. The displacement of a diagonally reinforced connection rejoin with the waste-tire mixture showed a 3.3% increase with a 3% decrease of the resistance capacity. In the model of the connection rejoin with more waste-tire mixture and rebar anchored over the boundary of the connection rejoin.

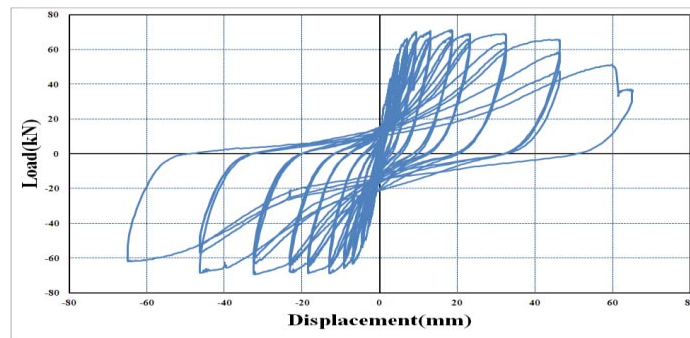
Fig.5. Load – displacement curve, NCJ-1

1) Load-displacement, NCJ-1: In NCJ-1 with normal concrete, the initial cracking occurred at a displacement of 2.78mm under a load of 38kN on the face at which the column and the beam are in contact. This crack increased as more load was placed on it. Additionally, the maximum fracture occurred after forcing the load up to a displacement of 32.45mm. The load-displacement curve is shown in Fig.5. and the final fracture shape is shown in Fig.6.[3]

In the load-displacement graph of NCJ-1, the maximum displacement was 62mm and the load was 70KN in the normal concrete case.

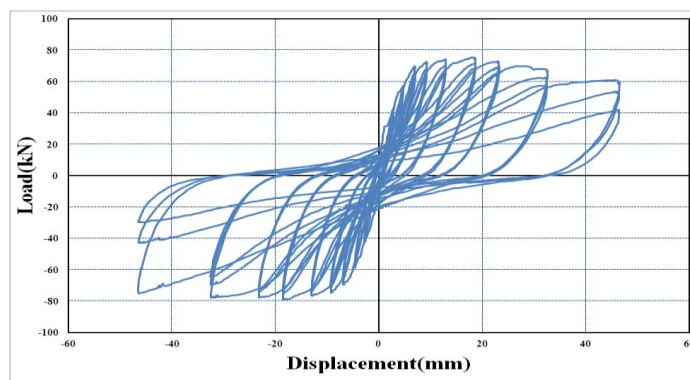
Fig.7. Load – displacement curve, TCJ-1

In TCJ-1 with waste-tire-mixing concrete, the initial crack occurred at a displacement of 2.78mm under loading of 40kN. Loading was done on the face at which the column and the beam are connected. A shear crack occurred on the upper end of the connection rejoin, as well.

Maximum fracturing was noted after forcing in the negative (-) direction. The size of the crack is 23.18mm. The load-displacement curve is shown in Fig.7 and the final fracture shape is shown in Fig.8.

Regarding another aspect of TCJ-1, for the same case but with the waste-tire mixed concrete, the initial crack occurred at a point of 30mm on the beam away from the face of the connection rejoin at which the column and beam are in contact. The concept of “strong column-weak beam” was realized in TCJ-1, although the sections of column and beam are identical, with a plastic hinge on the beam to conform to the “strong column and weak beam” principle. In addition, no particular improvement, such as improved energy absorption, was noted in TCJ-1 with the waste-tire-mix, with maximum stress of only 78KN and maximum displacement of 45mm. This explains why TCJ-1 does not show more displacement in this case. It is estimated that the main rebar in the beam is not anchored over the boundary of the connection rejoin. Instead, it is anchored only to the boundary. Eventually, the connection rejoin itself behaves separately without forming a body consisting of the column and the beam at the joint due to the insufficient anchorage capacity.

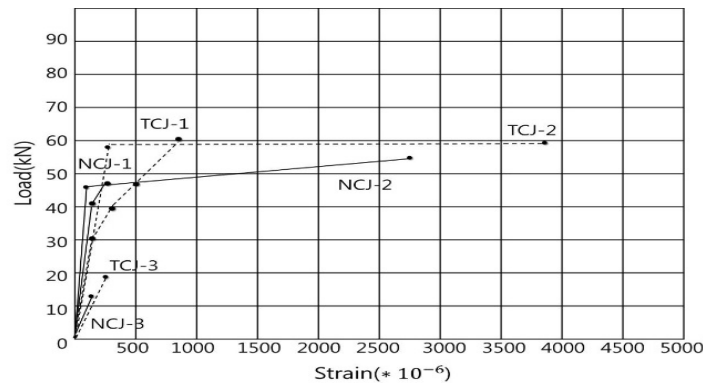
Fig.17. Strain of rebar for Type-1 at the s1 measuring point

The load deformations for Types 1, 2, and 3 with rebar are shown in Fig.17. [3]

It is estimated that the test frame with the mixture of waste tire chips has a stronger reinforcement effect of the main anchor bar and the beam-column joint than the other cases.

Approximately fourfold the deformation, without a conspicuous decrease of the resistance capacity, was noted in TCJ-1 at the c1 concrete strain gauge.
