Evaluation of the Performance of New Laminated Composite Shells for Motorcycle Helmets

Abstract — Motorcycles are considered a cost-effective and major means of transportation, particularly in the developing countries. However, motorcyclists are at higher risk of head and brain injuries in road crashes, which is the primarily cause of most of the fatalities occurred. Wearing a protective helmet is an efficient way for the safety of the motorcyclist, since it reduces the severity of head injuries through absorbing the impact energy during accidents. The main components of the helmet are the outer shell and the shock absorbing foam liner. The helmet performance depends to a great extent on the enhancement of the properties of the materials used to provide protection. This paper studied experimentally the protection performance of new laminated composite shells compared with that of an Acrylonitrile Butadiene Styrene (ABS) shell. The shell prototypes were fabricated in the form of an open face helmet, composed of a laminated composite structure reinforced with various fabric performs and materials. Expanded polystyrene foam was used for the shock absorbing liner and its compressive p

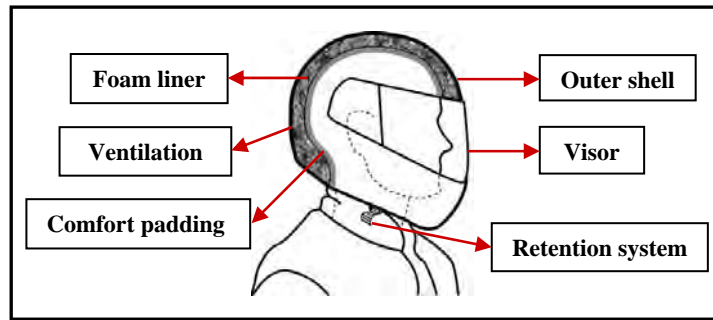
Fig.1. The components of a full-face motorcycle helmet.

exhaled air and humidity are vented out. The retention system serves to keep the helmet firmly on the rider's head [8],[10],[11]. Figure 1 shows the components of a full-face motorcycle helmet.

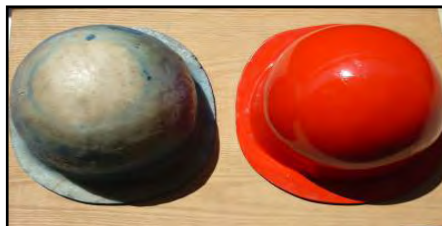
Fig.3. The helmet shell two pieces mold.

The helmet shells were prepared in the form of three-layer laminated composite structure, consisted of an upper layer of woven fabric and two layers of glass fiber mat. First, the fabrics were molded in the form of flat panels for the preliminary impact test. After that, the fabric samples were prepared and molded in the form of an open face helmet. The helmet outer shell mold was manufactured as two parts, a positive and a negative type molds as shown in figure 3. The shell mold was designed to be larger to some extent than the foam liner, so the liner can easily fit into the cavity of the shell, which also corresponds to the anatomy of the wearer's head. Polyester resin was used as the polymer matrix mixed with the catalyst and the accelerator. The fabric samples were impregnated with the resin layer after layer, placed in the negative type mold and pressed into the mold by means of the positive mold to achieve the desired shape. The laminated composite shells were left to cure at room temperature for 24 hours.

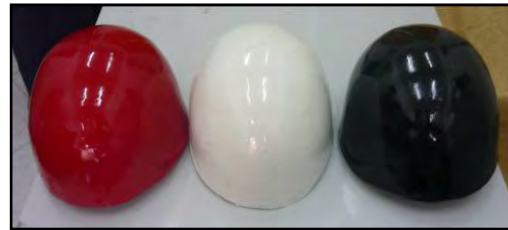
Fig.5. The helmet shell prototypes after finishing.

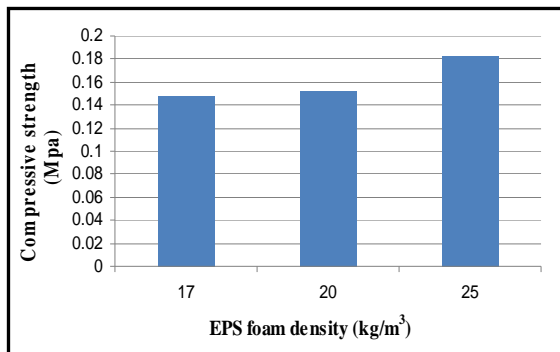
Fig. 6. Compressive strength of the EPS foam specimens.

Figures 6 and 7 present the results of compressive strength test applied on EPS foam specimens of different densities and their percentage of deformation after applying load. It was clear from the results that, the compressive strength of the EPS foam specimens is related to their density, which is a ratio of the foam density to the density of the solid from which it is made. The compressive strength of the foam specimens increased with increasing density, and the EPS specimen with density 25 kg/m³ recorded the highest compressive strength and the lowest percentage of deformation. This may be interpreted to that, increasing density leads to decreasing cells size, which means more of the solid is contributing to the foam mechanical properties rather than the air gaps within the cells. The EPS foam deformation behavior is related to its linear elasticity that arises from bending in the cell walls [27].

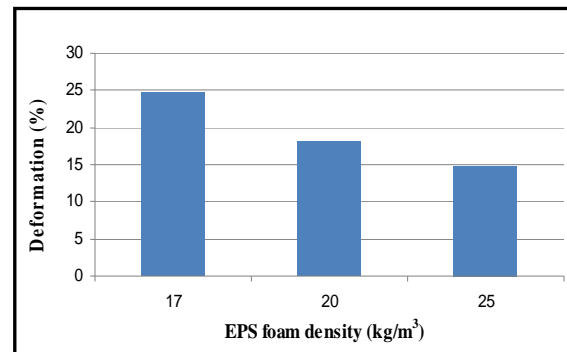
Fig.7. Deformation percentage of the EPS foam specimens after applying load.

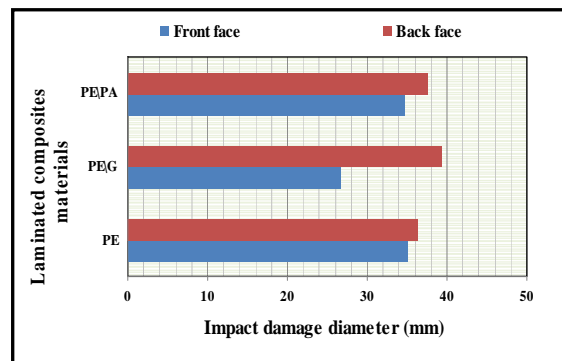
Fig.11. Damage diameter in the front and back faces of the specimens.

impact energy. However, the damage resulting from the striker mass has a different effect on the front and the back faces of the specimens due to the laminated composite structures capability of bearing loads. Using woven fabric in the upper layer of the laminated composite structure enhanced in resisting cracks propagation, and the glass fiber mat porous structure assist in good wetting with the matrix and improved the fiber/matrix interfacial bonding. In figure 8, the 100% polyester composite specimen suffered from matrix cracking and delamination in the front and back faces in addition to depression. In figure 9, the polyester/glass composite specimen suffered matrix cracks in both faces, delamination and fibers breakage in the back face and there is no penetration observed in the specimen. It had the smallest damage diameter in the front face area, while in the back face it had the biggest one, although it had the smallest dent depth. This may be related to glass fiber ability to absorb impact energy and the high stiffness of the composite structure produced due to the good fiber/matrix interfacial bonding. In figure 10, the polyester/polyamide composite specimen exhibited damage through matrix cracking, delamination, indentation and fibers breakage in both faces. It has the biggest dent depth compared to the other composites. Also, it was cleared that the extension of damage at the back faces of the specimens is larger than that of the front faces for all the shells specimens, and the dent depth varied due to the reinforcement materials properties, see figures 11 and 12.

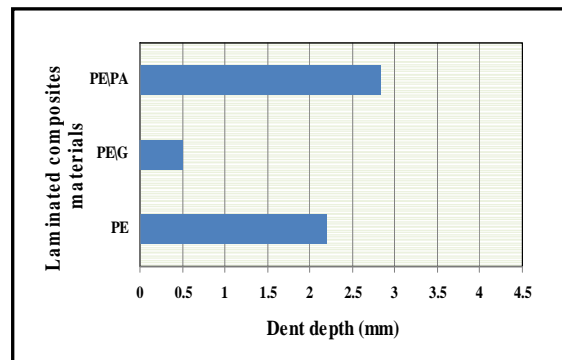
Fig.12. Dent depth of the specimens.

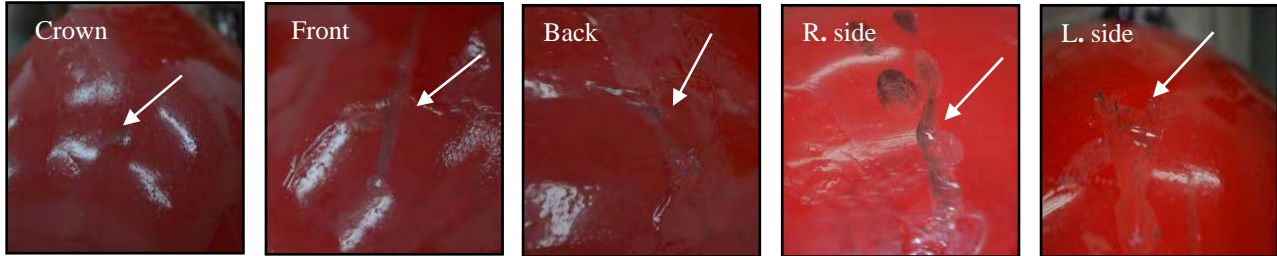
Fig.13. The impact damages occurred on the 100% polyester helmet composite shell on different impact sites.

The produced laminated composite helmet prototypes and the ABS thermoplastic helmet were subjected to low velocity impacts, and their damage behaviour was detected by using visual inspection of the damage zone and X-ray radiography. The laminated composite shells absorbed the impact energy through damage mechanisms as clarified in figures 13-21. Figure 13 shows the damages that occurred on different impact sites of the 100% polyester laminated composite shell. At the crown, right side, back and front sites of the shell, the impact load caused matrix cracks and scratches in the painted layer on the shell surface. At the left side of the shell, there are matrix cracks and breakage, delamination and fibers pullout in the lower glass fiber mat layer of the composite structure as observed from the internal view of the shell in figure 14-a. This may be related to the interlaminar shear stress that makes the cracks initiate delamination to the lower glass fiber mat layer and to the fiber/matrix interfacial bonding in this impact point. The EPS foam liner suffered plastic deformation and absorbed a lot of the impact energy on the shell left side, which leads to crushing of the foam cells in this area,

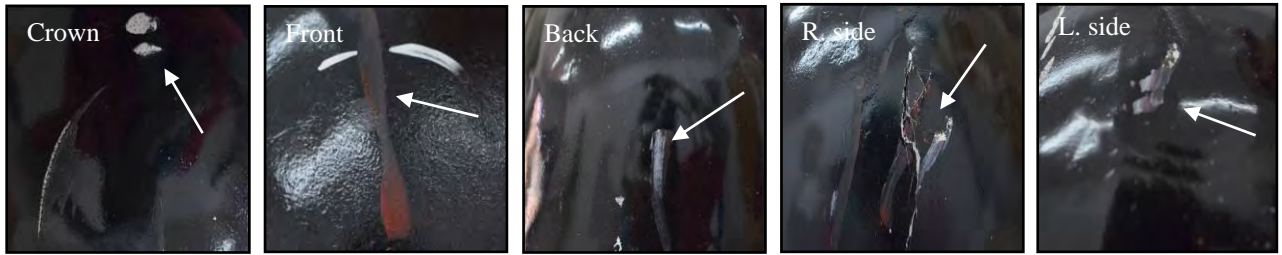
Fig.19. The damages occurred on the polyester/pol

Figures 19 shows the damages that occurred on different impact sites of the polyester/polyamide laminated composite shell. At the crown, front, left side and back sites of the shell, the impact load caused matrix cracks and scratches on the shell surface. Polyamide fibers have high elongation to fracture and excellent adhesion to resin which enhance the fiber/matrix interfacial bonding. At the crown and the right side of the helmet shell, there are matrix cracks and breakage, delamination and fibers pull out in the lower layer of glass fiber mat in the composite structure and it was cleared in the shell internal view as shown in figure 20-a. The EPS foam liner absorbed a lot of the impact energy and there is no fracture in the liner body, see figure 20-b. Figure 21(a-c) shows the X-ray radiograph images of the internal view of the polyester/polyamide laminated composite shell at the crown, front and right side sites. The dark areas in the X-ray radiograph images show the impact damages occurred. It was obvious from the different views of the shell that, the cracks didn't propagate in the shell body and no penetration occurred.

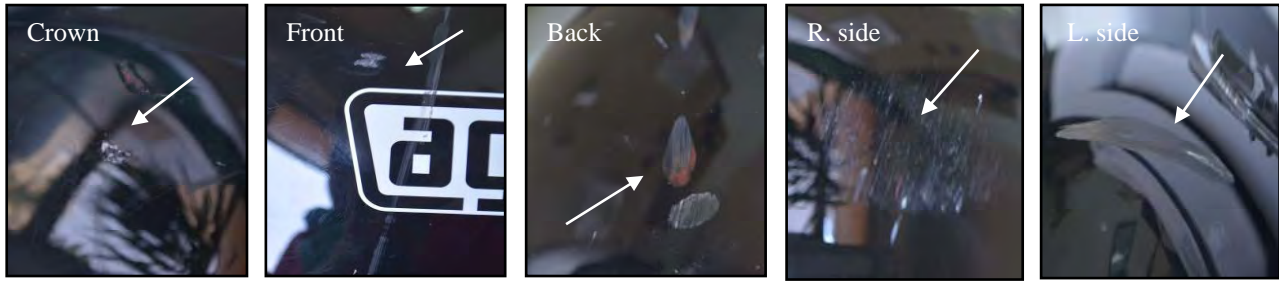
Fig.22. The damages occurred on the ABS helmet at different impact sites.

Figures 22 and 23 show the impact response of the ABS helmet after applying the test. It was observed from figure 22 that, there are cracks and scratches on the shell surface on the impact sites of the helmet. At the crown and the right side of the helmet, there was plastic deformations appeared. The shell absorbs a lot of the impact energy due to its elasto-plastic nature. The EPS foam liner absorbed the impact energy that leads to crushing of the foam cells in these areas, and there is no fracture observed in the liner body. Figure 23 shows the X-ray radiograph images for the internal view of the ABS shell at the crown and the right side impact sites. It was clarified from the shell views the deformations areas in the shell body and there is no penetration occurred.
